# Guidelines for Retrofitting Bleachers

UNITED STATES  
**CONSUMER PRODUCT SAFETY COMMISSION**  
WASHINGTON, DC 20207 THE CHAIRMAN

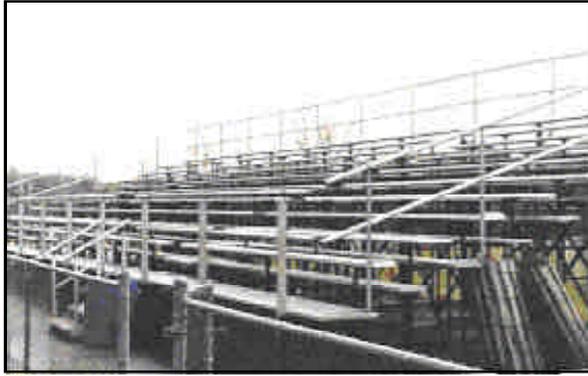
Figure 1: Permanent bleachers

Bleachers are structures that provide tiered or stepped seating, generally without backrests, that come in various configurations and sizes. They generally fit into one of four categories: permanent/stationary, portable/movable, telescopic/folding, and temporary. Figures 1, 2, and 3 are photos of permanent, portable, and telescopic bleachers, respectively. Temporary bleachers are typically stored in pieces and are intended for use only during specific events, such as circuses, golf tournaments, and parades. These guidelines apply to all four categories of bleachers.

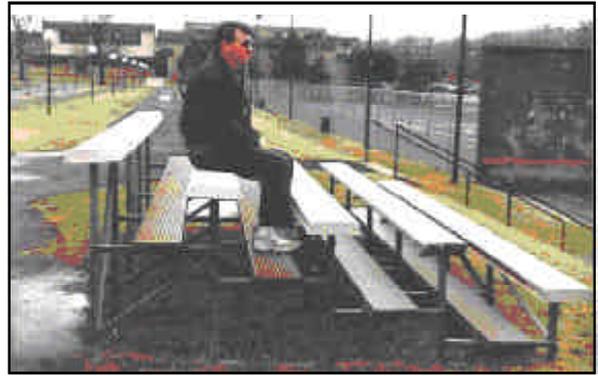
Figure 2: Portable bleachers

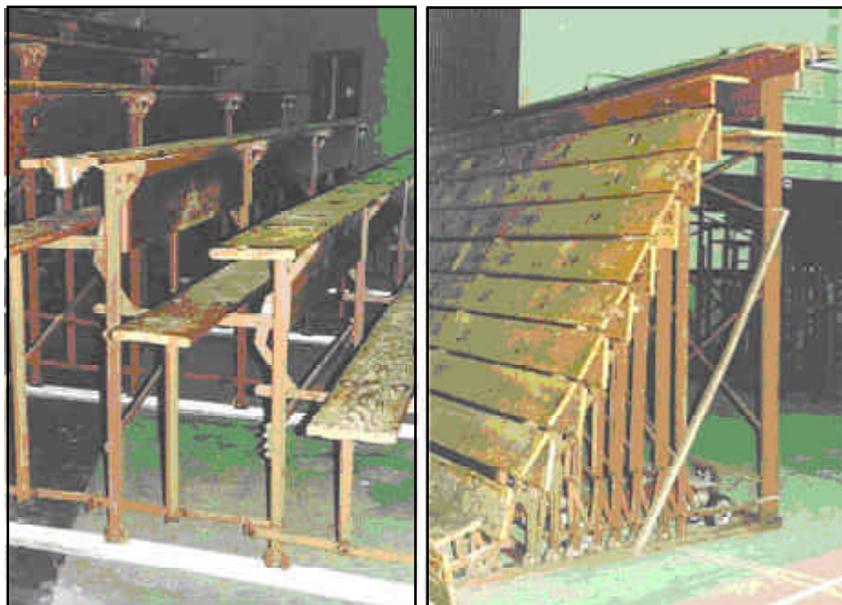
Figure 3: Telescopic bleachers (open and closed positions)

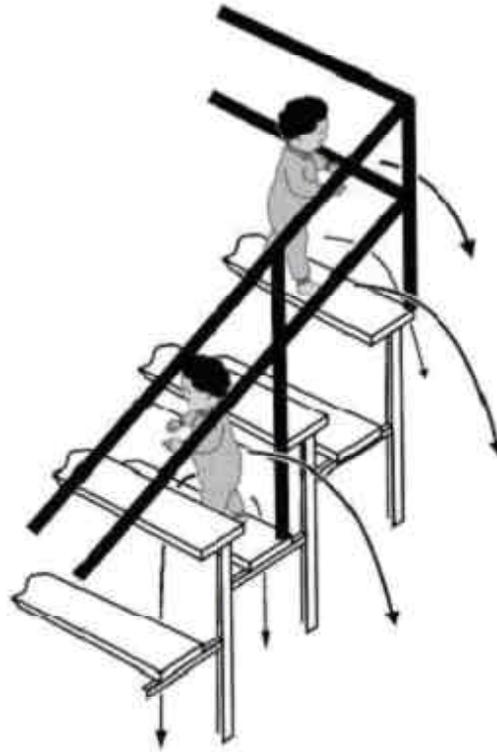
Figure 4: Inadequate guardrails and openings that permit falls from bleachers

Falls from bleachers can occur when guardrails are missing from the backs or open sides of the bleachers. Falls from bleachers can also occur when there are openings between components in the seating and guardrails that are big enough to permit a person to pass through them. These openings can exist in the following areas (and are shown in Figure 4): (1) between components of the guardrail, (2) between components of the seating, such as between the footboard and seatboard, and (3) between the bottom rail of the guardrail and the footboard or seatboard. These guidelines provide recommendations to prevent these falls.

Figures 6 and 7 depict the bleachers shown in Figure 4 after being retrofitted in order to satisfy the recommendations made for guardrails and openings. Figure 6 shows the preferable method of guardrail construction, which has only vertical components between the top and bottom rails. The vertical rails are spaced to prevent passage of a 4-inch sphere. Figure 7 shows guardrails that have been retrofitted with chain link fencing attached to the existing railings. If chain link fencing is used on guardrails, CPSC recommends only using chain link fencing which has a mesh size of 1.25-inch square or less, shown in Figure 8, so that the widest measurement of the openings measures 1.75 inches or less. This will discourage climbing by young children.

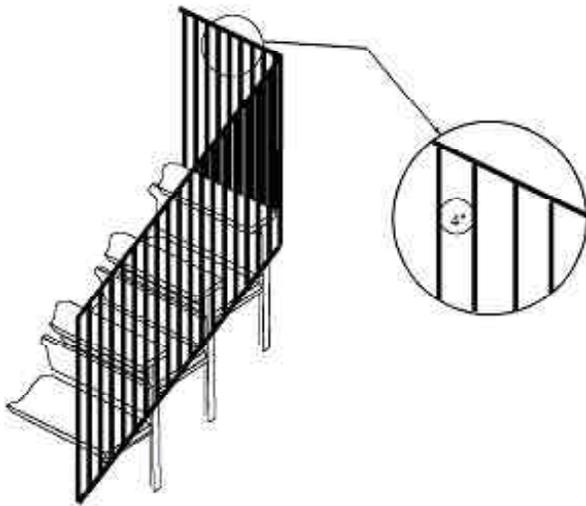
Figure 6: Vertical guardrail members spaced to

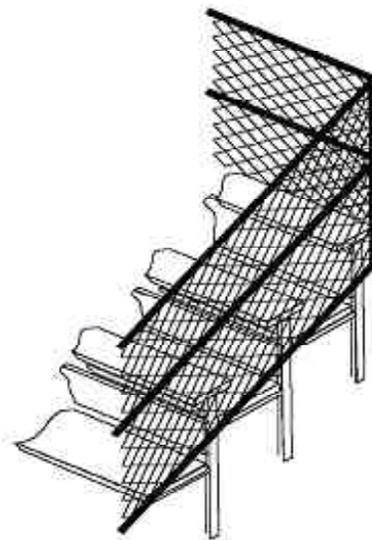
Figure 7: Guardrails with chain link fencing prevent passage of a 4-inch sphere attached to the existing railings

CPSC recommends use of rigid materials, such as aluminum extrusions or grating material, to close the openings between the seating components. CPSC does not recommend the use of chain link or other fencing material to close openings under the seatboards and footboards for a number of reasons. Depending on how the fencing is attached, it can introduce potential trip hazards, it can allow combustible and unsanitary debris to collect under the seats that is not easy to remove, it can be difficult to inspect for any break in integrity, and it can encourage children to play on it and hang from it.

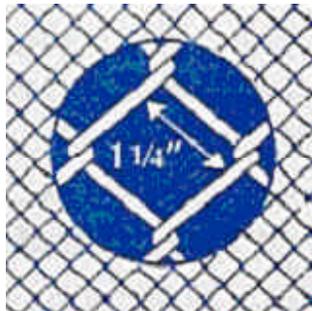
Figure 8: Chain link fence with 1.25" mesh to discourage climbing by young children

- The preferable guardrail design uses only vertical members as in-fill between the top and bottom rails. If there are openings in the in-fill that could provide a foothold for climbing, the widest measurement of the opening where the foot could rest should be limited to a maximum of 1.75 inches. Opening patterns that provide a ladder effect should be avoided. If chain link fencing is used on guardrails, it should have a mesh size of 1.25-inch square or less.
